External Walls Seminar Working together to get it right

NHBC External Walls Seminar

Increasing industry awareness of defects of external walls

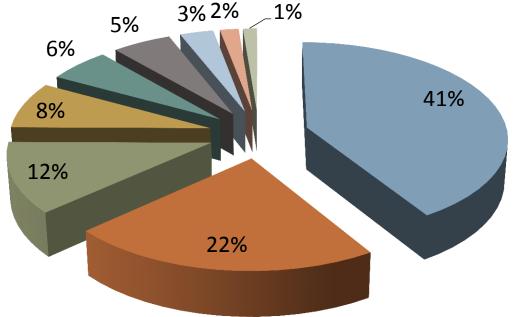
Claim statistics – Cavity trays & DPC's

Cavity tray incorrect position

- Cavity tray missing
- Cavity tray inadequate joins
- Cavity tray incorrect end detail
- Cavity tray incorrect type
- Vertical/horizontal dpc incorrect position
- Vertical/horizontal dpc missing
- Cavity tray no weep vents
- Vertical/horizontal dpc incorrect type

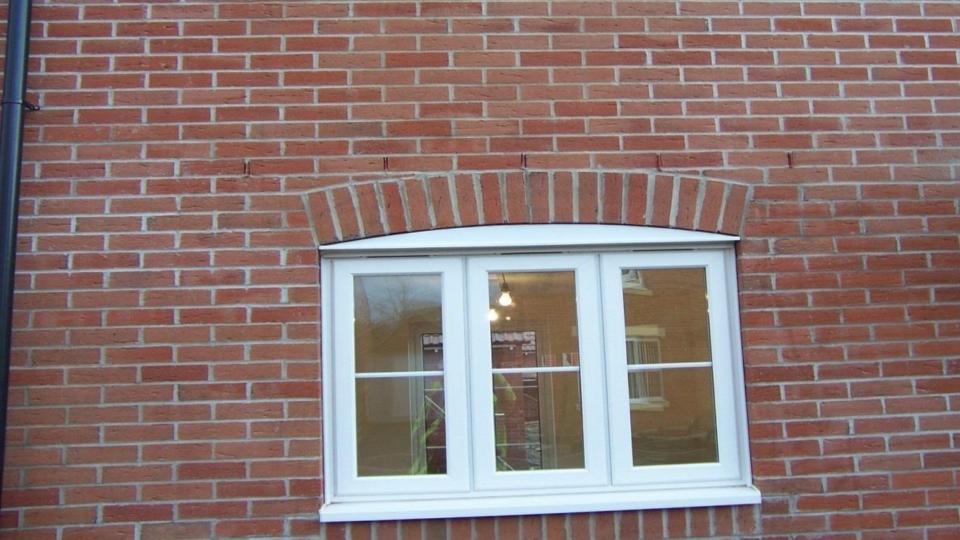
Correct spacing and number of weep holes. Shame about location

Is there a cavity tray at this height?

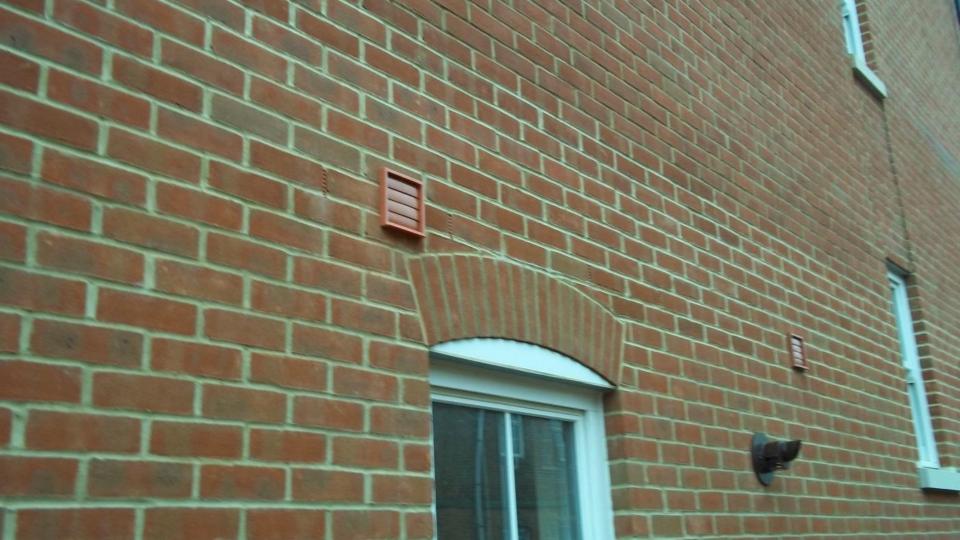
Weep holes installed, but at the wrong height

Vent gone through tray??

Is there a cavity tray at this height?

Cavity tray cut short - at least 25mm past closer or to cover the lintel (whichever is greater)

No stop end

Weeps wrong place

Is this stop end satisfactory?

Full of mortar. Weep blocked if there is one

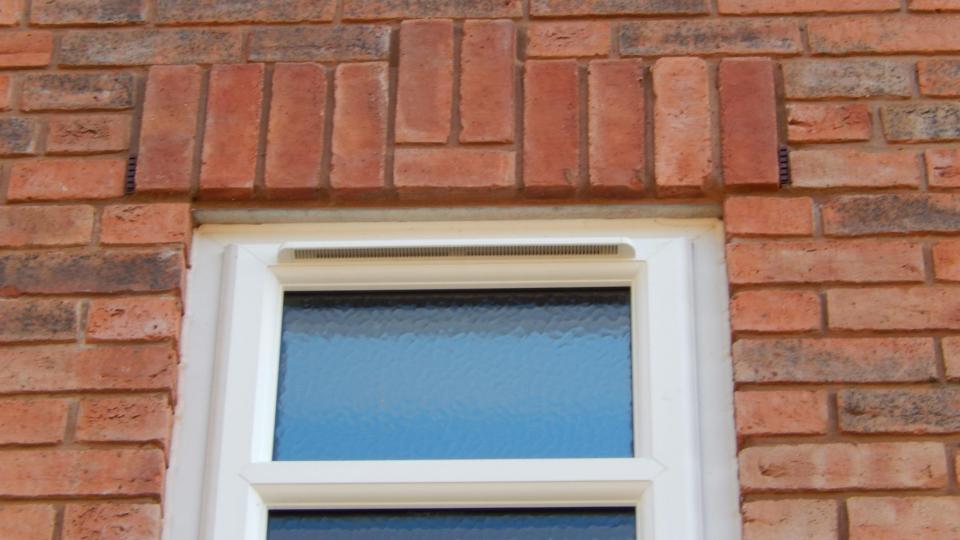
Missing weep holes

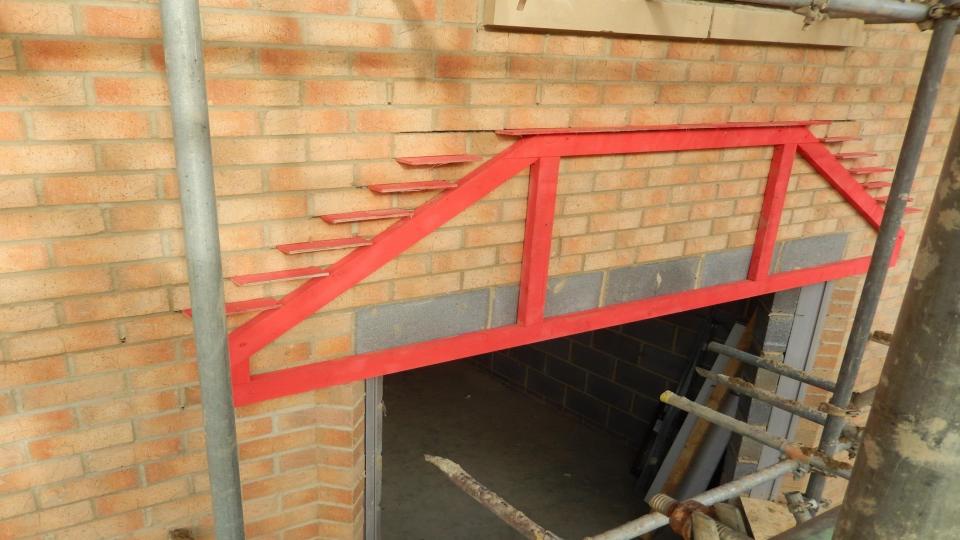
Weeps here. Tray too high?

No sign of broken bond. Indicates missing or incorrectly located trays/stop ends

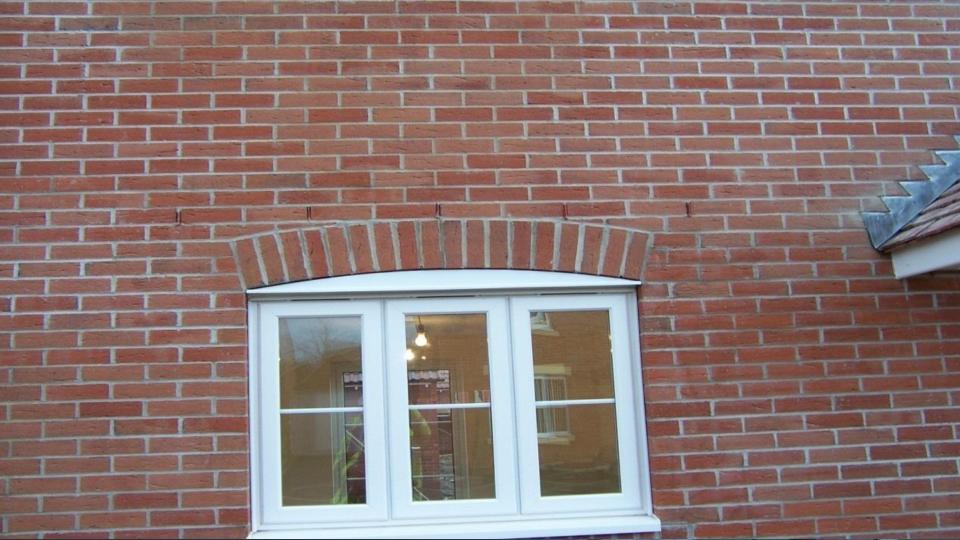
Brick dust would suggest grinding

Is there a tray?

No sign of a weep hole?

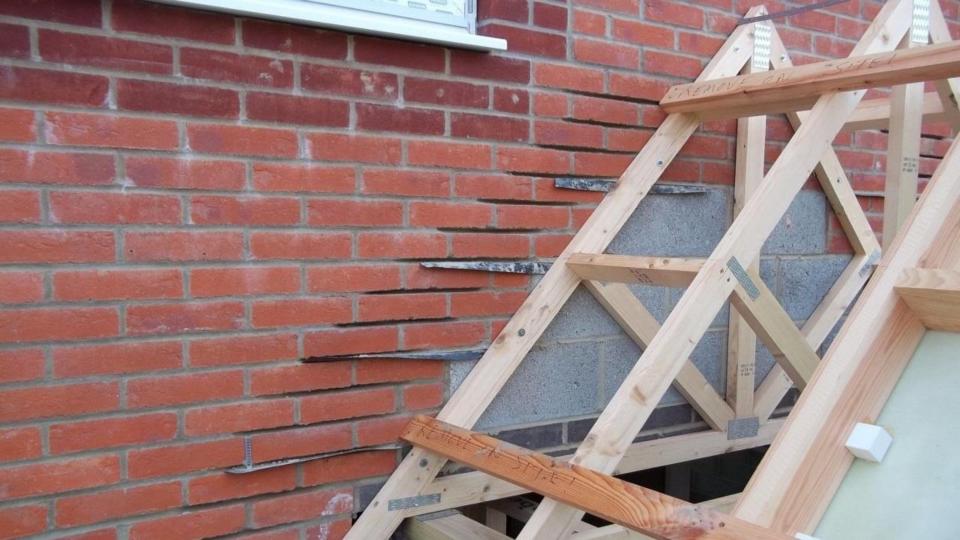
Trays discharge into roof space

Trays not stop ended

No trays here

Joints ground out

No weep

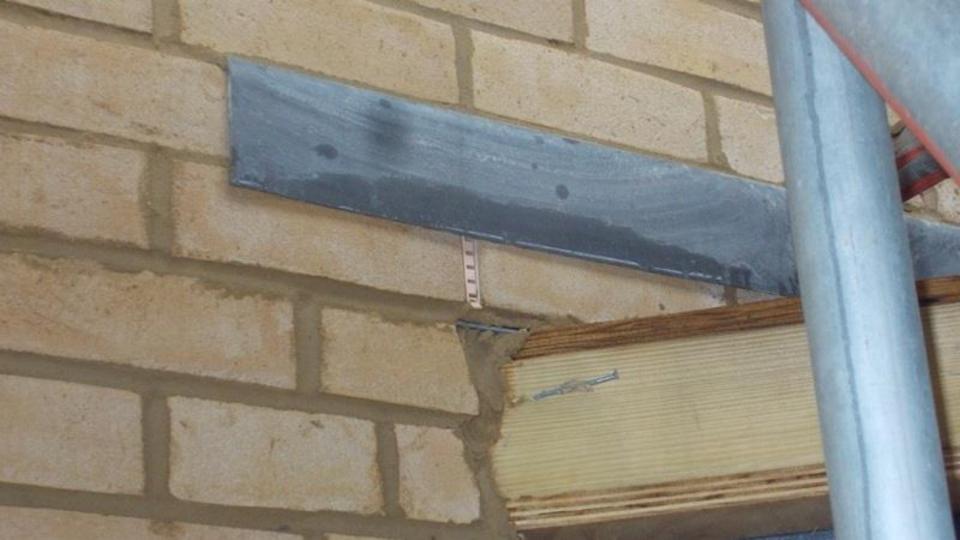
Flashing built in the correct place

Tray and weep hole too low

VDPC required

Timber in direct contact with brickwork

Weep hole blocked

Bed joint not raked out

Flashing ground into joint

No tray installed

Flashing not to correct depth

No stop end or weep hole

Flashing installed above the tray

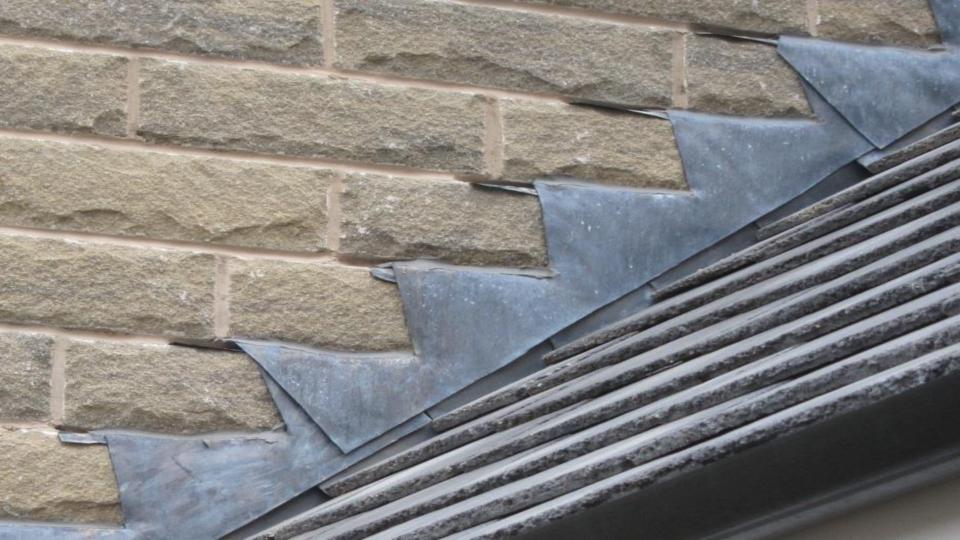
Flashing installed above the tray

Flexible DPC installed wrong

Joint ground out

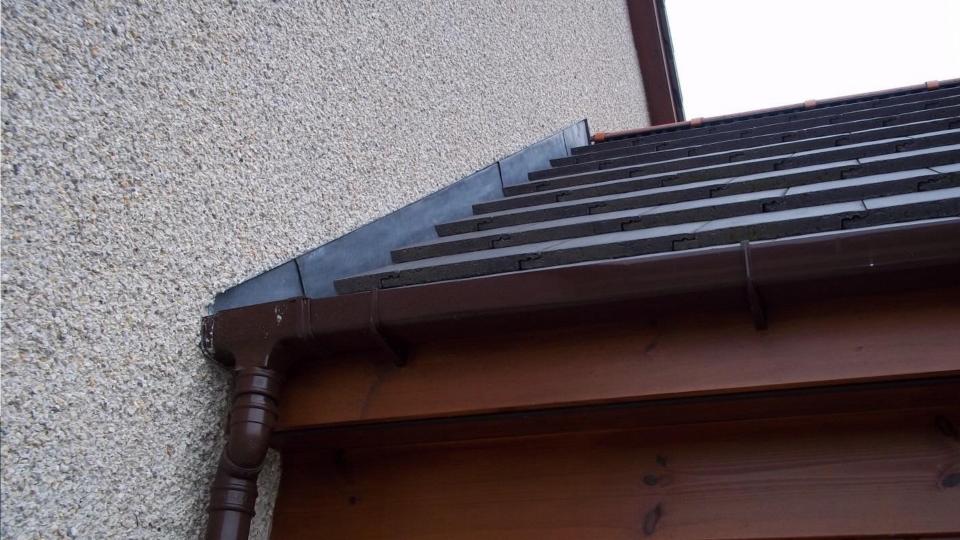
How is the flashing linked to the stepped tray?

No weep hole at bottom of stepped tray

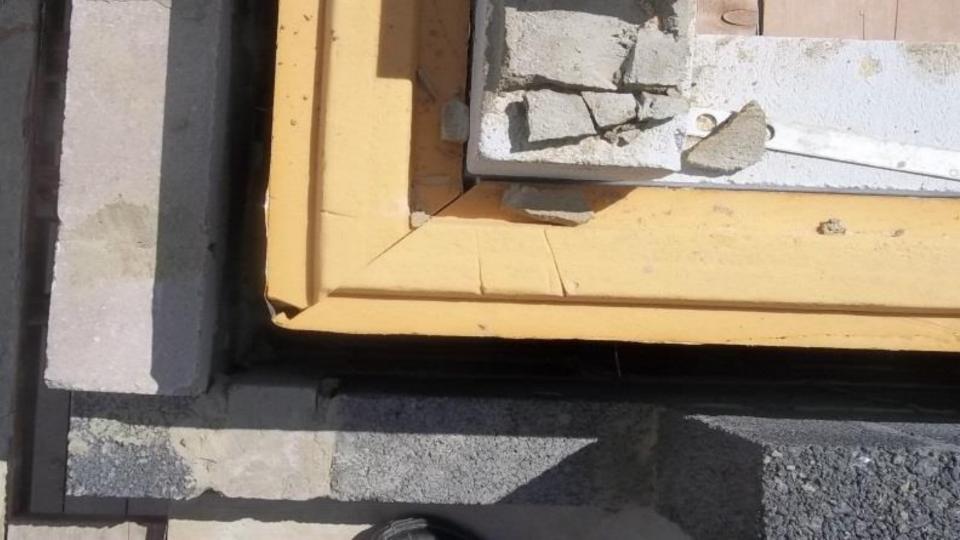
Missing insulation creates cold spots

Cavity closer too narrow to close cavity

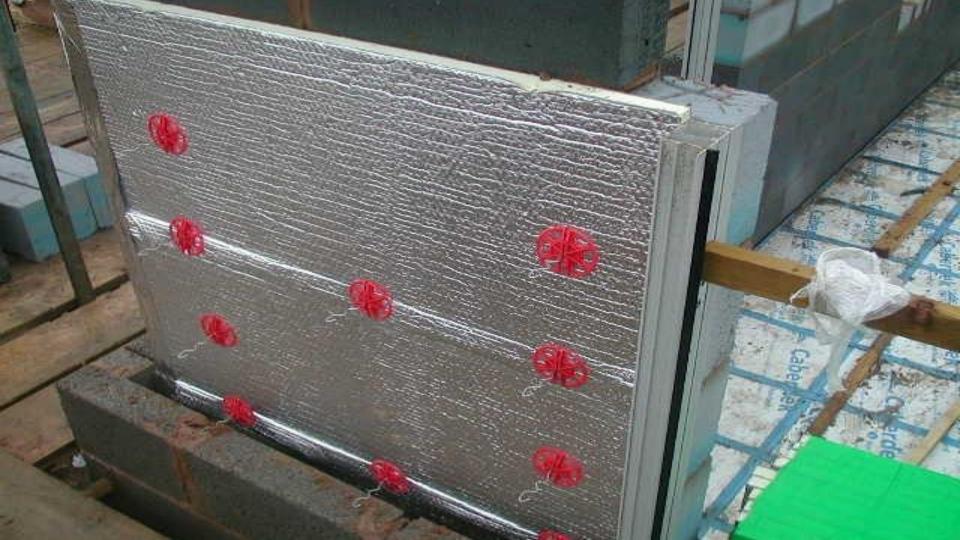
Poorly cut insulation around window former

Mortar not struck off

Insulation missing from below lintel

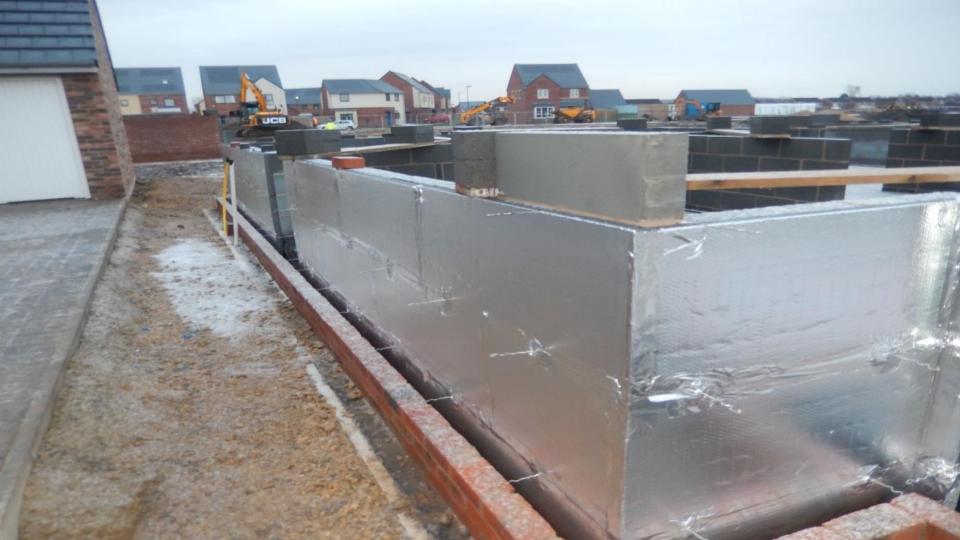
Under-filled Insulation

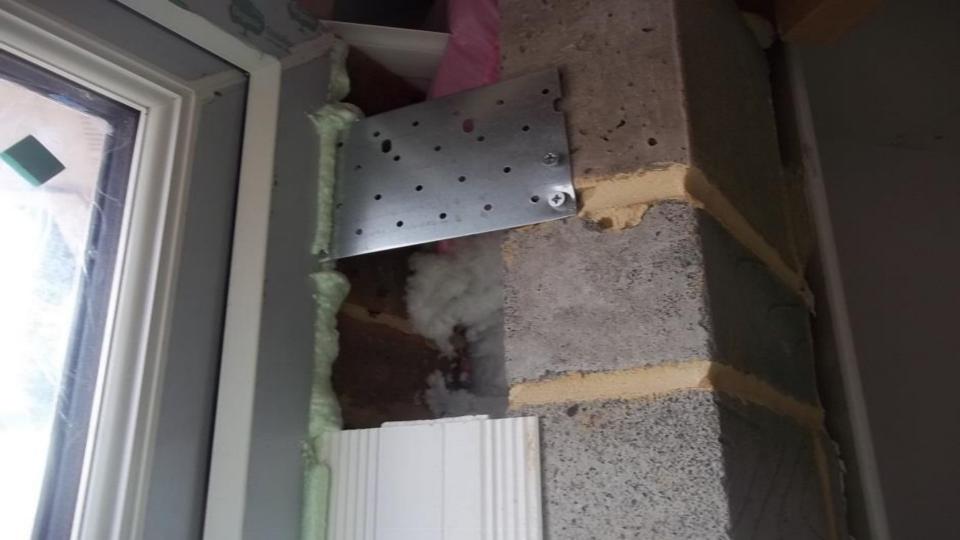
Cavities must be closed for fire at window openings (AD B3 <u>6.3</u>)

Very short cavity closer

Mortar across insulation joints

Not tight to internal leaf

Heat loss issue

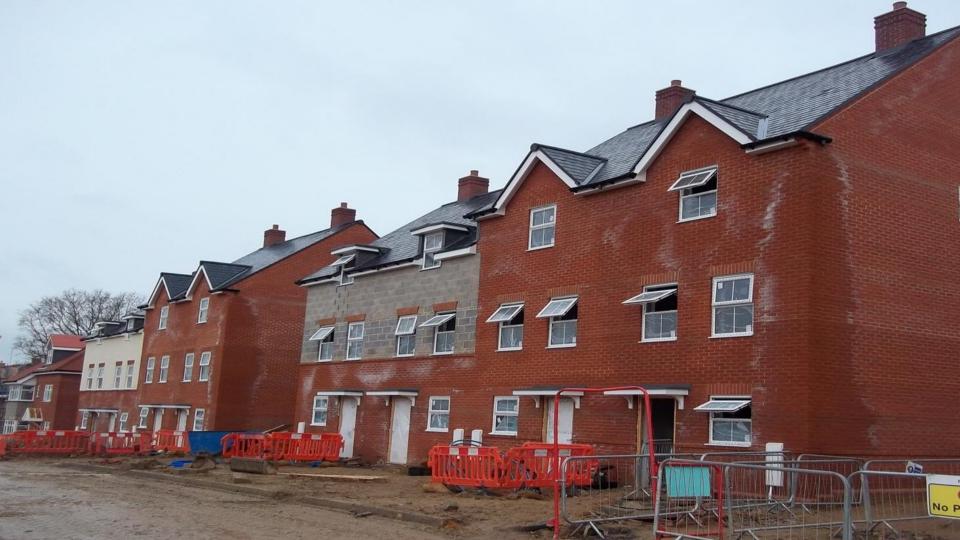
Typical cracking in proprietary render systems

Scratch coat too thin. Should be at least 10mm

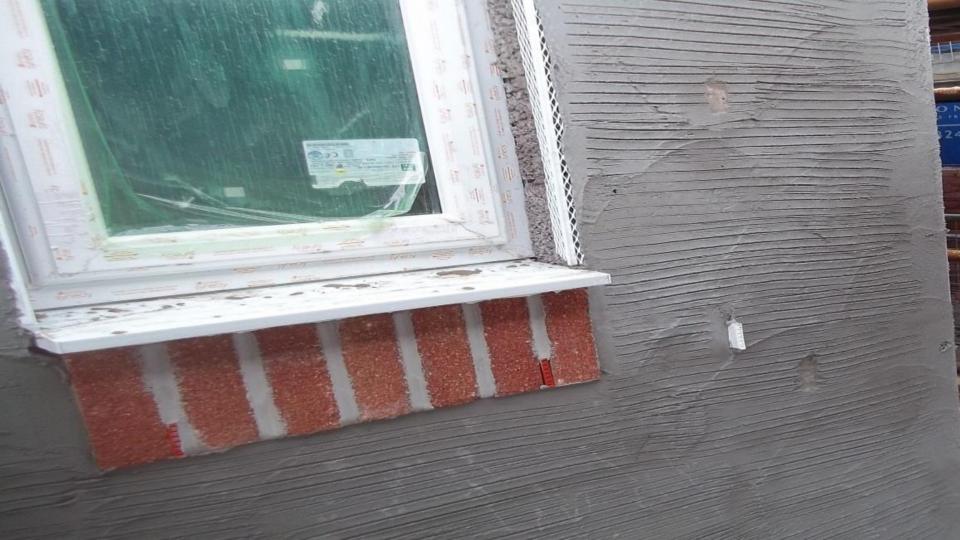
Scratch coat too thin (10mm)

Reveals missed

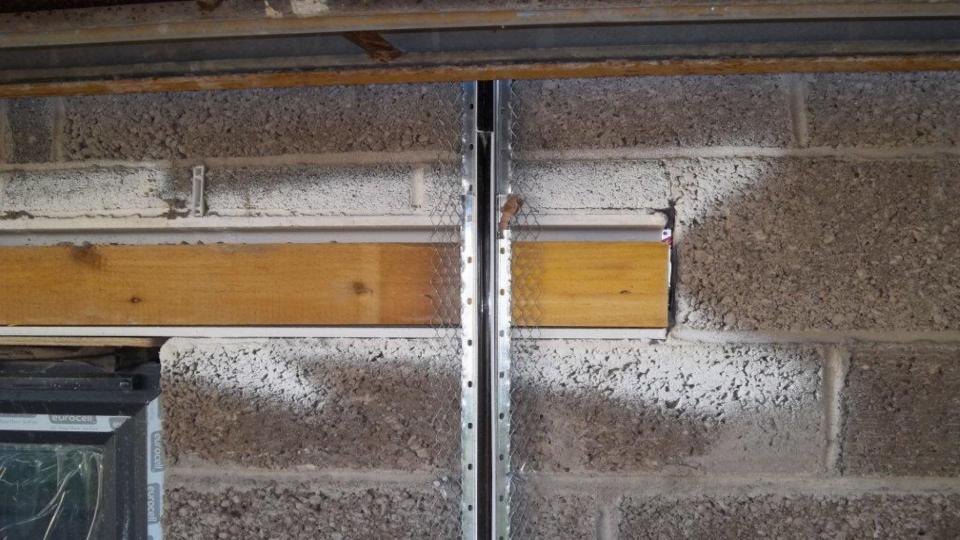
Movement and decay issues leaving this here!

Lintel continues behind render movement bead

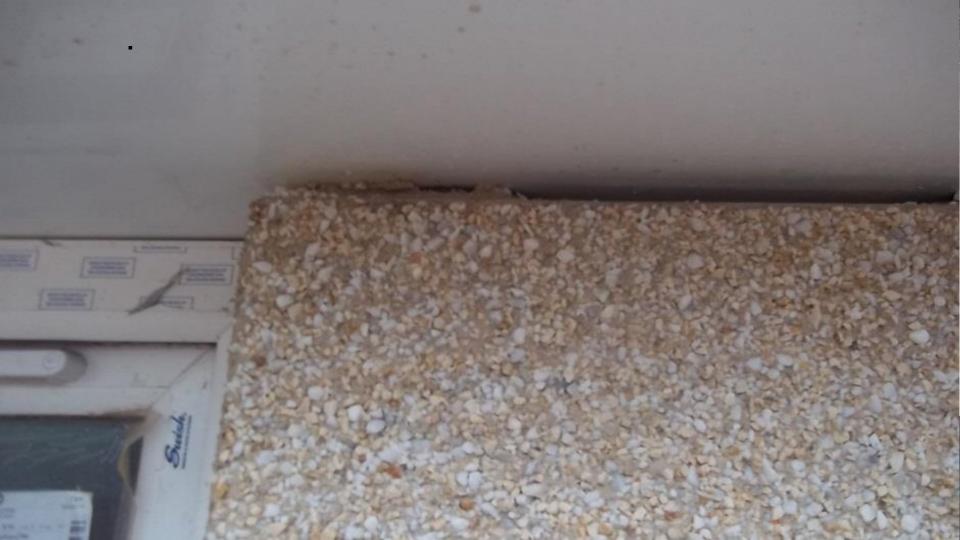
Reveal too tight to the soffit

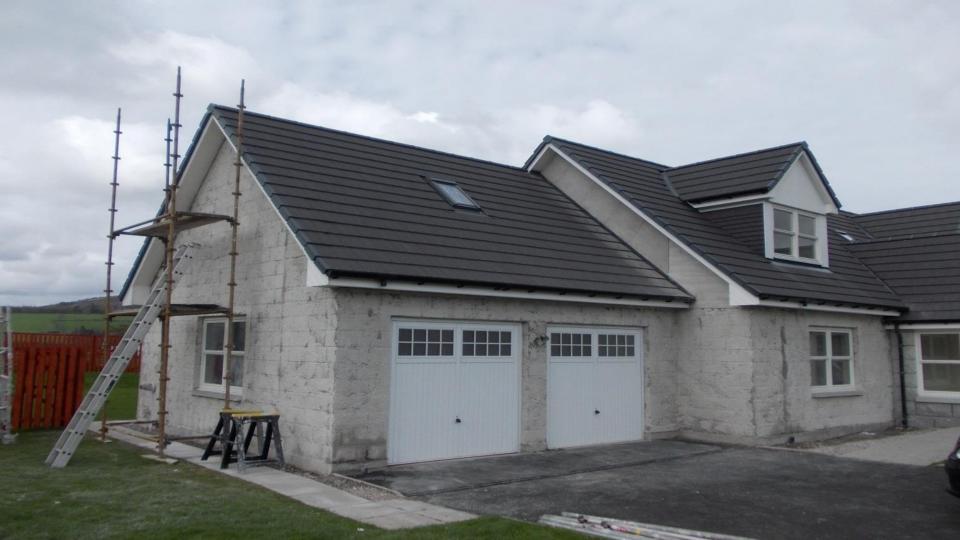
Neat stop beads to allow suitable settlement gap

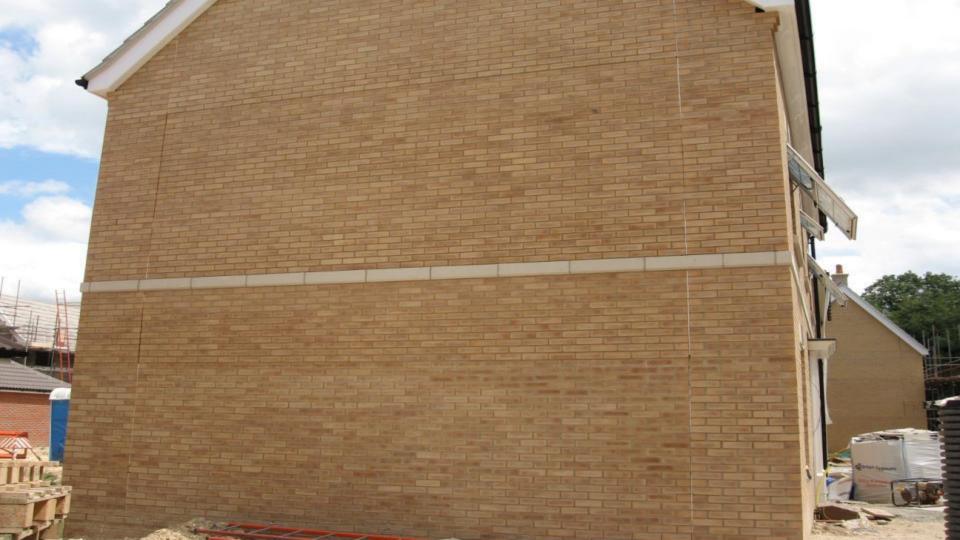
Brick movement joints do not continue through feature stone

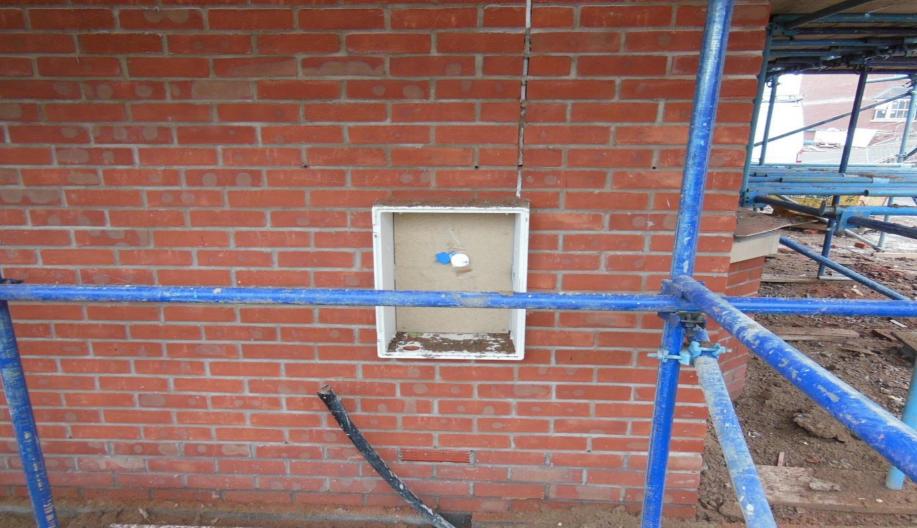
Toothed brickwork and blockwork!

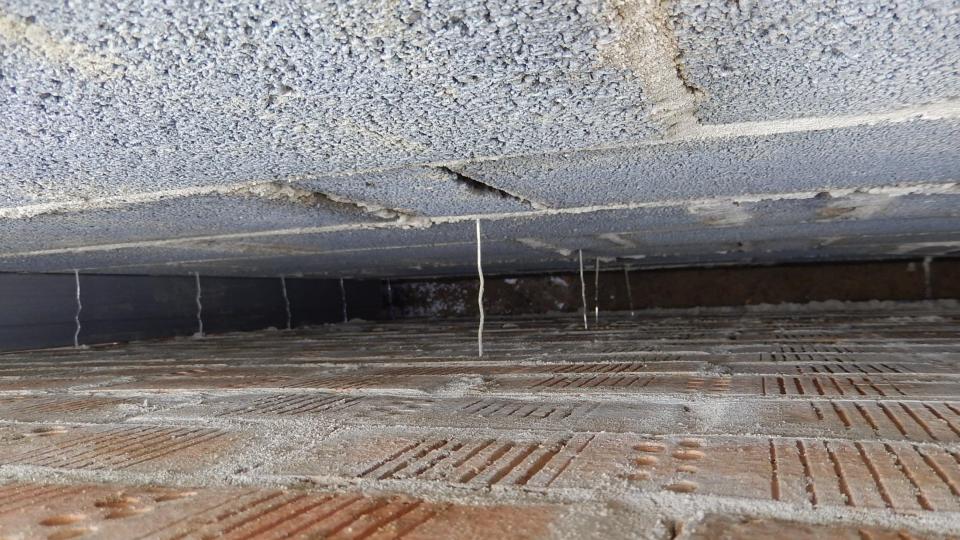
If we wanted to be picky, open joint here

50mm embedment?

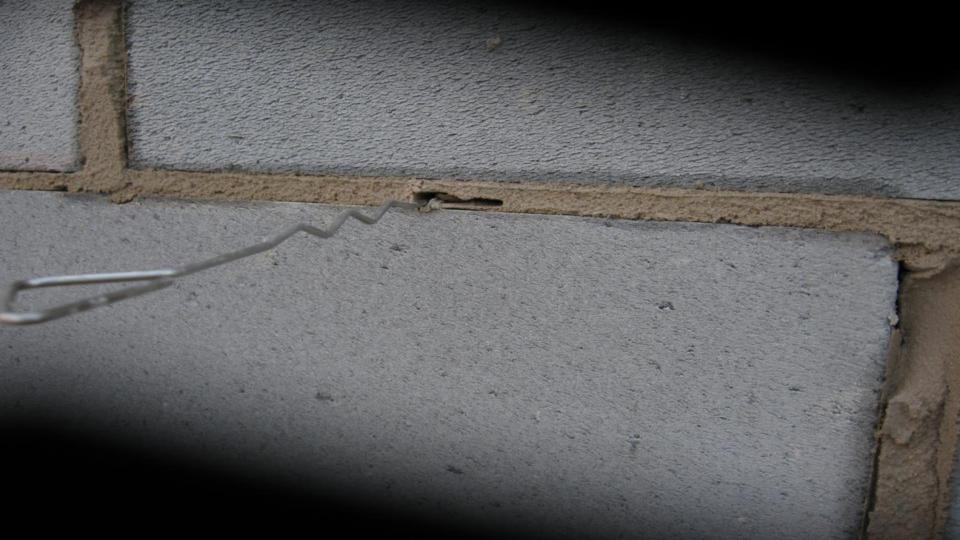
Tell-tale slot confirms ties installed after laying.

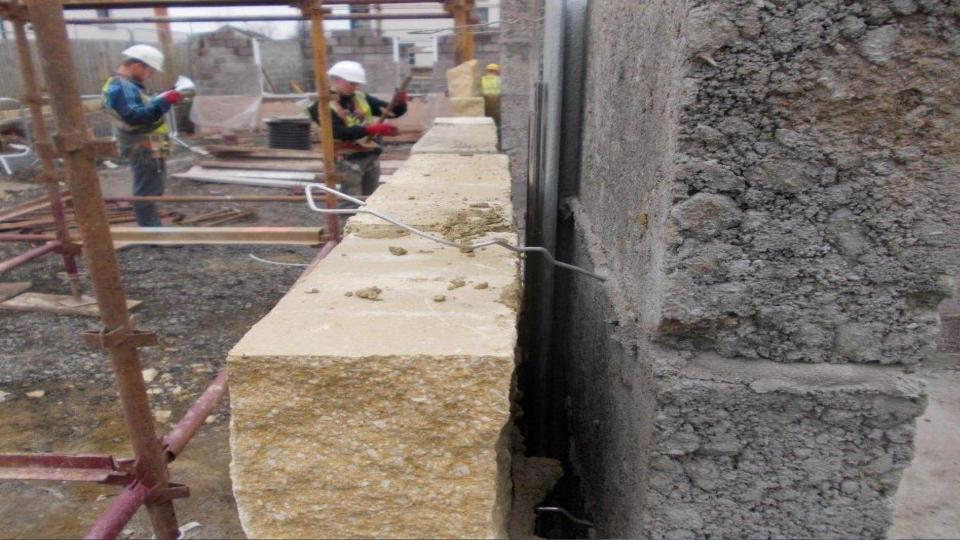
Gauging out

Ties too long and sloping inwards

Cavity width?

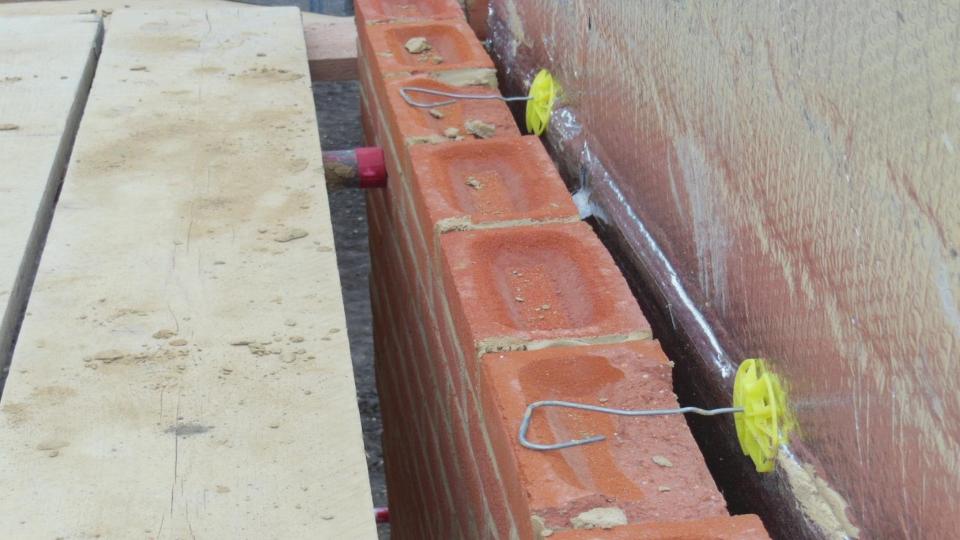
Wall tie not bedded 50mm to blockwork

Back of frog broken off to keep gauge

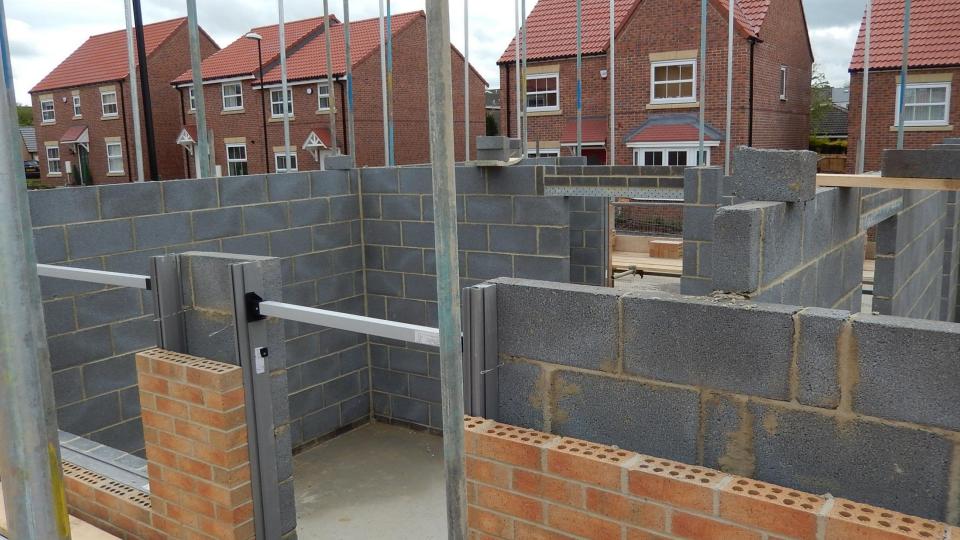
Lintel dry bedded

Daylight on this one!

Not just lintels, no packing to steel beam

- To ensure it is level
- To spread the load evenly
- Prevent passage of moisture
